**Flood Control Project Maintenance
Levee Inspections**

Maintenance Issue Types Only, Levee Inspection Report By Mile - Spring 2018

Reclamation District No. 0524 Middle Roberts Island

Waterway	Bank	Unit Miles	Inspection Start/End	Inspector
Unit No. 01 San Joaquin River	Left	6.20	04/24/2018 04/24/2018	Richard Willoughby

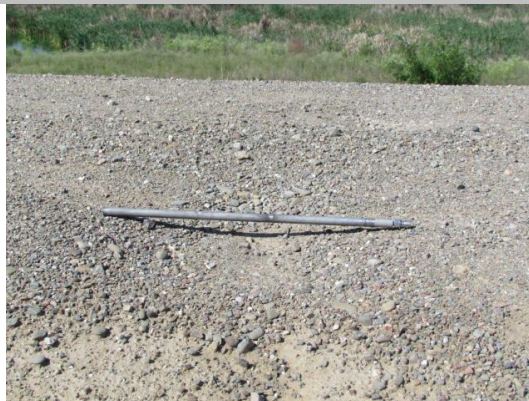
Photo 1 of 3 : SP_2018_RD0524_107_3_20180323_00008.jpg

LM Start	0.21	Rating **	M	Issue No.	3
LM End	0.21	Issue Type +	Ma	Location *	CR
Category	Earthen Levee			GPS Latitude/Longitude	
				Start	End
Item	Crown Surface / Depressions / Rutting			37.938890 °	37.938890 °
				-121.343657 °	-121.343657 °
DWR ID	DWR_RD0524_01_s_2016_3				
Comment Code					
C2 : Repair depressions or ruts in the crown or slope.					
Inspector Comment					
No change in status.

Looking west at 3" depression on levee crown. (Spring 2012)

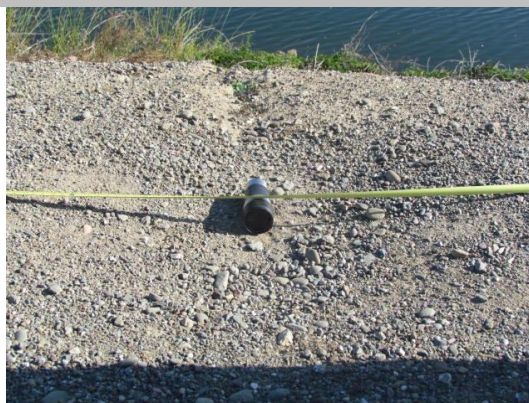
Photo 2 of 3 : SP_2018_RD0524_107_3_20180323_00009.jpg

Looking west at depression on levee crown near waterward shoulder.

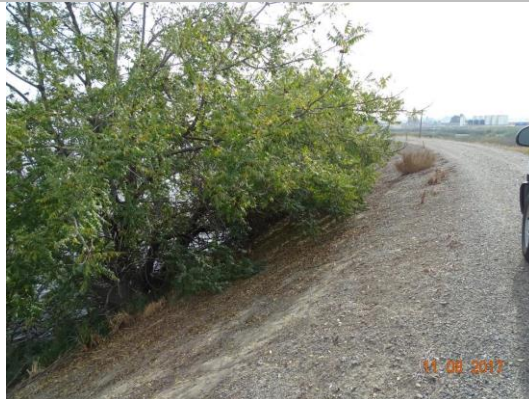
Photo 1 of 1 : SP_2018_RD0524_107_201_20180323_00280.jpg

LM Start	0.23	Rating **	U	Issue No.	201
LM End	0.23	Issue Type +	Ma	Location *	WS
Category	Earthen Levee			GPS Latitude/Longitude	
				Start	End
Item	Trim / Thin Trees			37.938648 °	37.938648 °
				-121.343480 °	-121.343480 °
DWR ID	DWR_RD0524_01_f_2016_201				
Comment Code					
T2 : Thin trees to allow visibility of the ground and room to flood fight.					
Inspector Comment					
Untrimmed trees on waterside slope.

Looking southeast at the waterside slope.

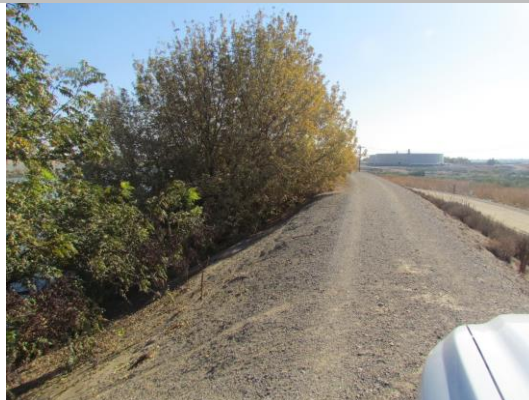
Photo 1 of 4 : SP_2018_RD0524_107_179_20180323_00247.jpg

LM Start	0.27	Rating **	U	Issue No.	179
LM End	0.27	Issue Type +	Ma	Location *	WS
Category	Earthen Levee			GPS Latitude/Longitude	
				Start	End
Item	Trim / Thin Trees			37.938438 °	37.938438 °
				-121.342883 °	-121.342883 °
DWR ID	DWR_RD0524_01_s_2014_179				
Comment Code					
T2 : Thin trees to allow visibility of the ground and room to flood fight.					
Inspector Comment					
Tree blocking view of waterside slope.

Looking east at untrimmed tree on waterward slope. (Fall 2016)

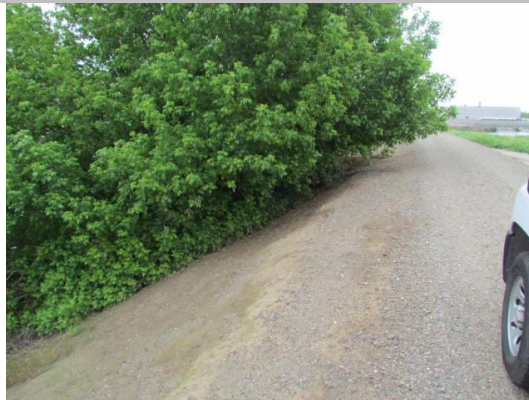
Photo 2 of 4 : SP_2018_RD0524_107_179_20180323_00248.jpg

Looking east at untrimmed tree on waterward slope (Spring 2016)

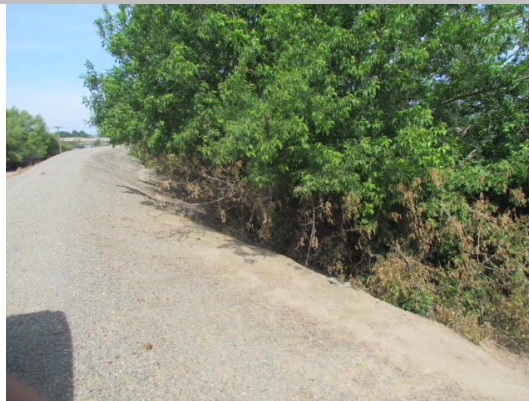
Photo 3 of 4 : SP_2018_RD0524_107_179_20180323_00249.jpg

Looking west at untrimmed tree on waterward slope. (Spring 2015)

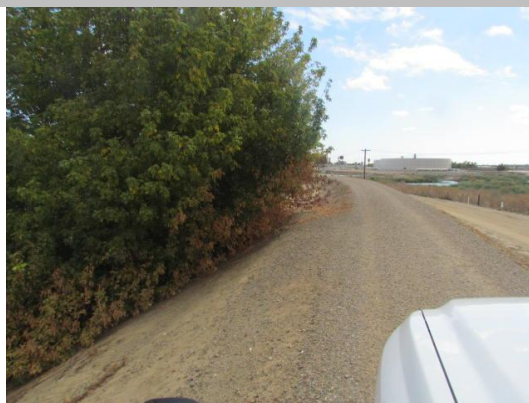
Photo 4 of 4 : SP_2018_RD0524_107_179_20180323_00250.jpg

Looking east at untrimmed tree on waterward slope. (Fall 2015)

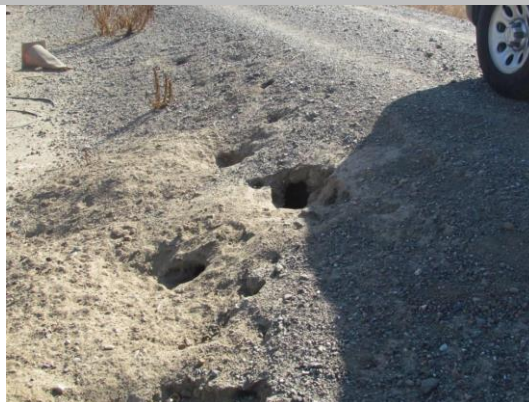
Photo 1 of 4 : SP_2018_RD0524_107_174_20180323_00237.jpg

LM Start	0.30	Rating **	U	Issue No.	174
LM End	0.32	Issue Type +	Ma	Location *	WS
Category	Earthen Levee			GPS Latitude/Longitude	
				Start	End
Item	Animal Control			37.938382 °	37.938412 °
				-121.342352 °	-121.341917 °
DWR ID	DWR_RD0524_01_f_2014_174				
Comment Code					
A1 : Exterminate rodents and backfill and compact or grout burrows.					
Inspector Comment					
Several rodent holes present at this site. No change at site during fall 2018 inspection.					
Active rodent activity during spring 2017 inspection. No change at site.

Looking southwest at several rodent holes on waterward slope. (Fall 2016)

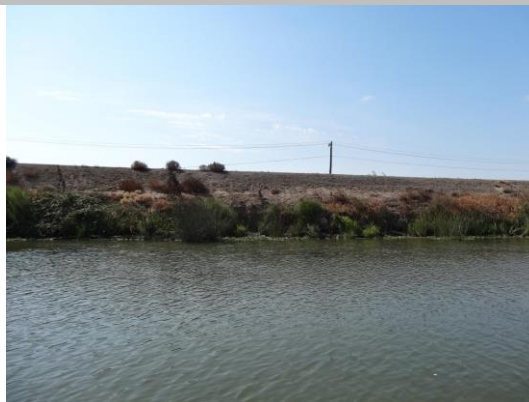
Photo 1 of 4 : SP_2018_RD0524_107_2_20180323_00004.jpg

LM Start	0.34	Rating **	M	Issue No.	2
LM End	0.34	Issue Type +	Ma	Location *	WS
Category	Supplemental			GPS Latitude/Longitude	
				Start	End
Item	DWR Erosion Survey			37.938461 °	37.938461 °
				-121.341526 °	-121.341526 °
DWR ID	RD0524U01RM40.93				
Comment Code					
Inspector Comment					
09/13/2017: There are two pocket erosions at the site; both erosions are around 10 ft long and 6 ft high. [2017 Site ID:RD0524U01RM40.93]

Front view of the erosion site.

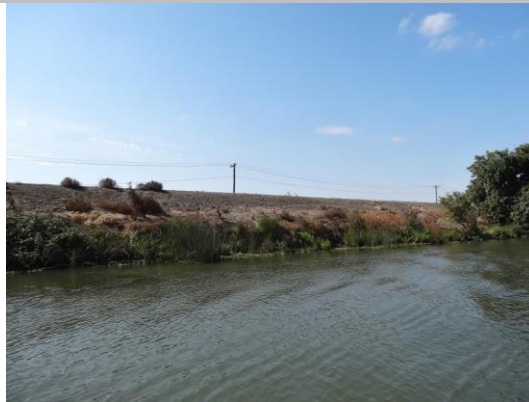
Photo 2 of 4 : SP_2018_RD0524_107_2_20180323_00005.jpg

Looking downstream of the erosion.

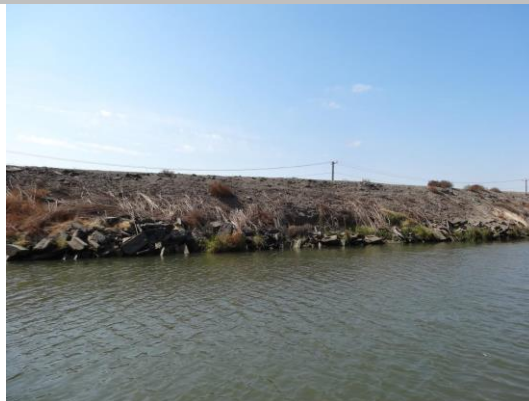
Photo 3 of 4 : SP_2018_RD0524_107_5_20180323_00013.jpg

LM Start	0.40	Rating **	M	Issue No.	5 (cont)	
LM End	0.40	Issue Type +	Ma	Location *	WS	
Category	Supplemental			GPS Latitude/Longitude		
				Start	End	
Item	DWR Erosion Survey			37.938870 °	37.938870 °	
				-121.340460 °	-121.340460 °	
DWR ID	RD0524U01RM40.99					
Comment Code						
Inspector Comment						
09/13/2017: No significant change observed.						
07/25/2016: More vegetation observed at the site.						
06/24/2015: No significant change observed.						
06/19/2014: No significant change observed.						
08/13/2013: No significant change at this site.						
08/07/2012: The erosion is at the upper levee slope, and likely caused by slope slip. The lower levee slope is covered with dense vegetation.						
[2017 Site ID:RD0524U01RM40.99]

Close view of the erosion.

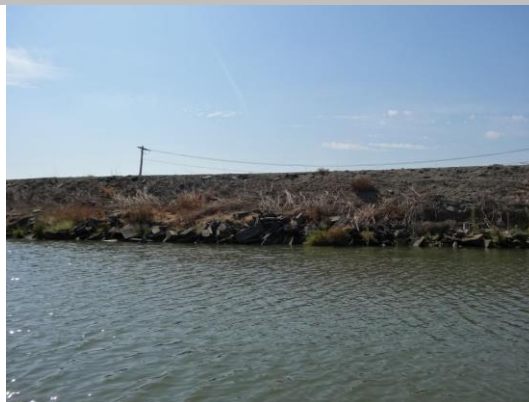
Photo 4 of 4 : SP_2018_RD0524_107_5_20180323_00014.jpg

Close view of the erosion.

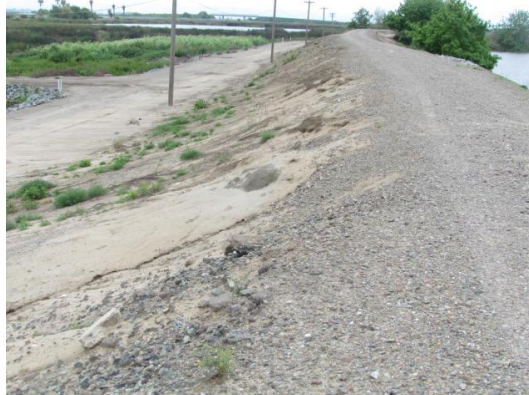
Photo 1 of 2 : SP_2018_RD0524_107_205_20180323_00285.jpg

LM Start	0.40	Rating **	U	Issue No.	205
LM End	0.46	Issue Type +	Ma	Location *	LS
Category	Earthen Levee			GPS Latitude/Longitude	
				Start	End
Item	Erosion / Bank Caving			37.938625 °	37.938695 °
				-121.340479 °	-121.339420 °
DWR ID	DWR_RD0524_01_s_2016_205				
Comment Code					
E2 : Schedule repair of erosion site prior to the next inspection.					
Inspector Comment					
Several damaged sites within this reach.

Looking at slope damage on landward slope.

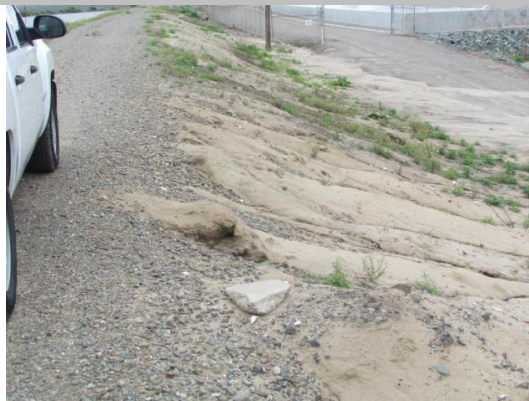
Photo 2 of 2 : SP_2018_RD0524_107_205_20180323_00286.jpg

Looking at slope damage on landward slope.

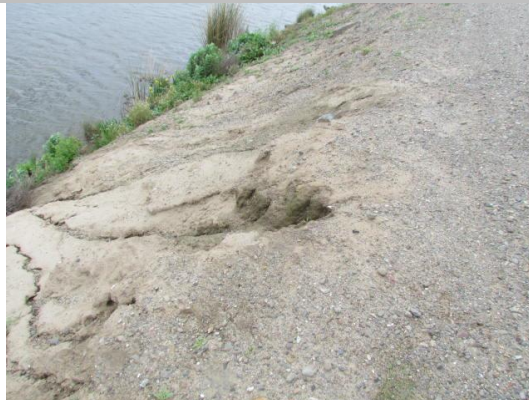
Photo 1 of 2 : SP_2018_RD0524_107_170_20180323_00232.jpg

LM Start	0.41	Rating **	U	Issue No.	170
LM End	0.45	Issue Type +	Ma	Location *	WS
Category	Earthen Levee			GPS Latitude/Longitude	
				Start	End
Item	Erosion / Bank Caving			37.938628 °	37.938688 °
				-121.340385 °	-121.339627 °
DWR ID	DWR_RD0524_01_s_2015_170				
Comment Code					
E2 : Schedule repair of erosion site prior to the next inspection.					
Inspector Comment					
Several slope instabilities within this reach.

Looking at slope damage on waterward shoulder (Spring 2016)

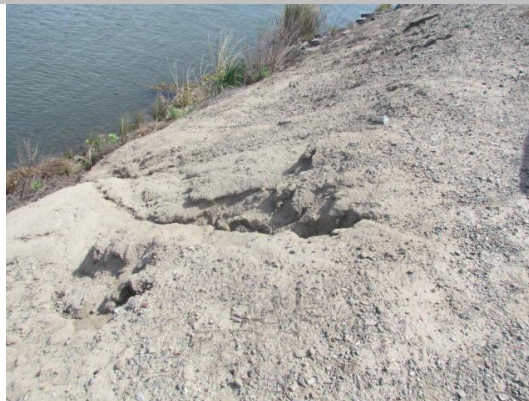
Photo 2 of 2 : SP_2018_RD0524_107_170_20180323_00234.jpg

Looking at waterward slope erosion.

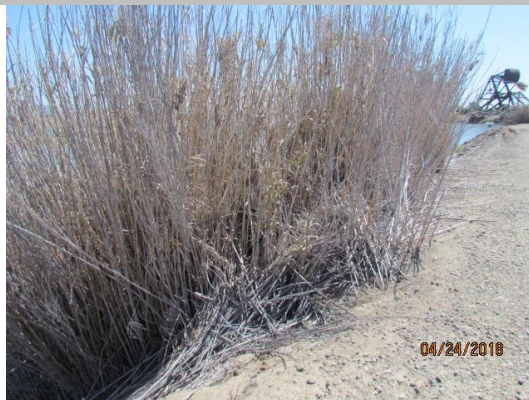
Photo 1 of 2 : SP_2018_RD0524_107_11_20180427_00488.jpg

LM Start	0.63	Rating **	U	Issue No.	11
LM End	0.64	Issue Type +	Ma	Location *	WS
Category	Earthen Levee			GPS Latitude/Longitude	
				Start	End
Item	Vegetation			37.938232 °	37.938160 °
				-121.336484 °	-121.336357 °
DWR ID	DWR_RD0524_01_s_2012_11				
Comment Code					
V2 : Remove the wild growth other than native grasses from the levee slopes.					
Inspector Comment					
Bamboo on waterside slope.

Looking at bamboo on waterward slope. (Spring 2018)

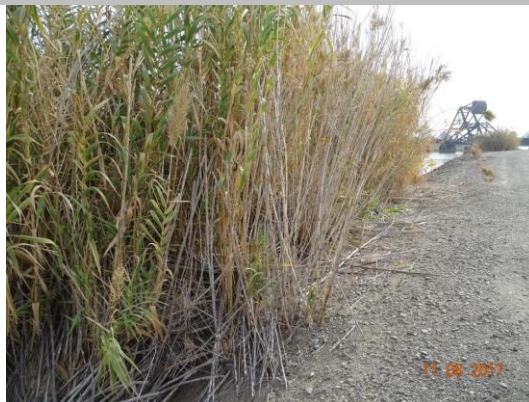
Photo 2 of 2 : SP_2018_RD0524_107_11_20180323_00019.jpg

Looking southeast at the waterside slope.

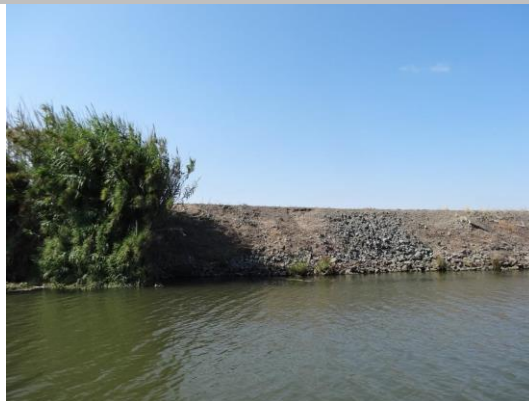
Photo 1 of 2 : SP_2018_RD0524_107_15_20180323_00031.jpg

LM Start	0.63	Rating **	M	Issue No.	15
LM End	0.63	Issue Type +	Ma	Location *	WS
Category	Supplemental			GPS Latitude/Longitude	
				Start	End
Item	DWR Erosion Survey			37.938247 °	37.938247 °
				-121.336503 °	-121.336503 °
DWR ID	RD0524U01RM41.26				
Comment Code					
Inspector Comment					
09/13/2017: The erosion was discovered by levee inspection. The erosion site is immediately downstream of tall vegetations. [2017 Site ID:RD0524U01RM41.26]

Front view of the erosion. The erosion is located at the shadow of the vegetation.

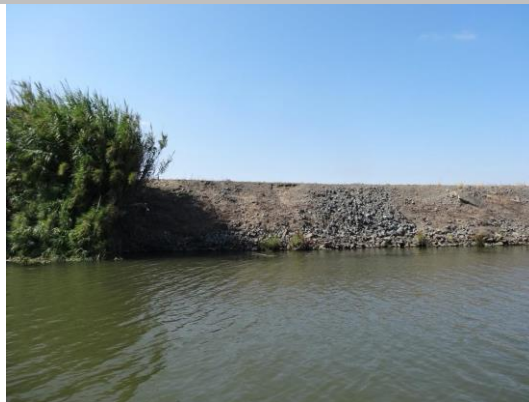
Photo 2 of 2 : SP_2018_RD0524_107_15_20180323_00032.jpg

Front view of the erosion.

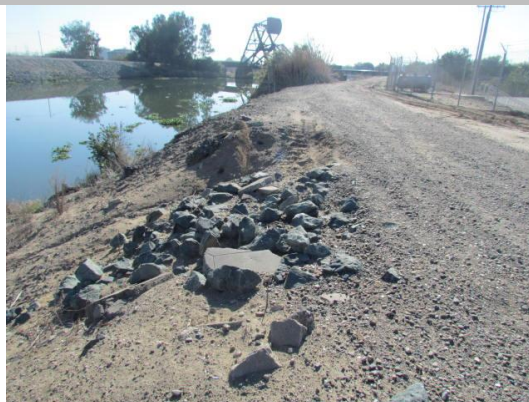
Photo 1 of 4 : SP_2018_RD0524_107_13_20180323_00024.jpg

LM Start	0.64	Rating **	M	Issue No.	13
LM End	0.65	Issue Type +	Ma	Location *	WS
Category	Earthen Levee			GPS Latitude/Longitude	
				Start	End
Item	Slope Stability			37.938105 °	37.938023 °
				-121.336288 °	-121.336173 °
DWR ID	DWR_RD0524_01_s_2012_13				
Comment Code					
S1 : Repair slope instability.					
Inspector Comment					
Depression extends from shoulder to mid levee slope two site with this section.

Looking southeast at depression on waterward shoulder fall 2015

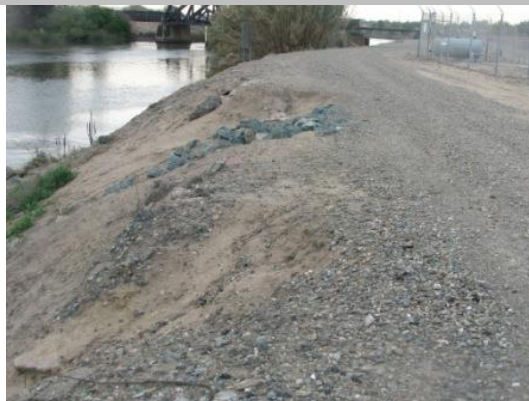
Photo 3 of 4 : SP_2018_RD0524_107_13_20180323_00026.jpg

View of the erosion.

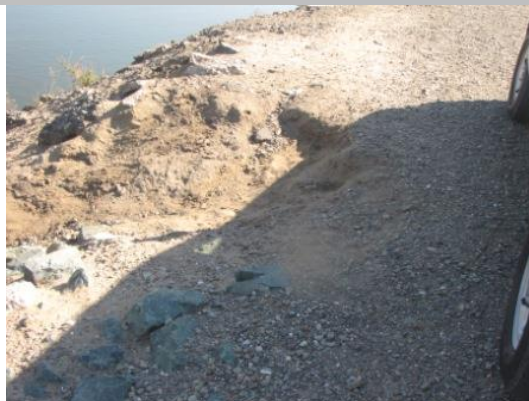
Photo 4 of 4 : SP_2018_RD0524_107_13_20180323_00027.jpg

Update view of the erosion site.

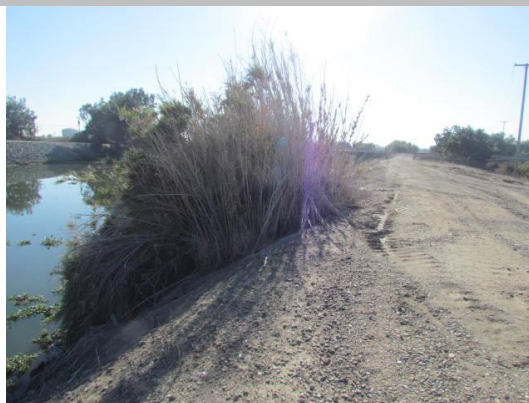
Photo 1 of 1 : SP_2018_RD0524_107_14_20180323_00028.jpg

LM Start	0.67	Rating **	U	Issue No.	14
LM End	0.67	Issue Type +	Ma	Location *	WS
Category	Earthen Levee			GPS Latitude/Longitude	
				Start	End
Item	Vegetation			37.937808 °	37.937808 °
				-121.335913 °	-121.335913 °
DWR ID	DWR_RD0524_01_s_2012_14				
Comment Code					
V2 : Remove the wild growth other than native grasses from the levee slopes.					
Inspector Comment					
Bamboo on waterside slope.

Looking south at dying bamboo on waterward slope. Fall 2015

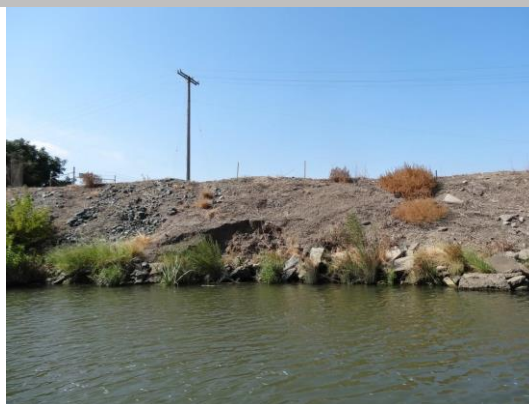
Photo 1 of 4 : SP_2018_RD0524_107_16_20180323_00033.jpg

LM Start	0.70	Rating **	M	Issue No.	16
LM End	0.70	Issue Type +	Ma	Location *	WS
Category	Supplemental			GPS Latitude/Longitude	
				Start	End
Item	DWR Erosion Survey			37.937577 °	37.937577 °
				-121.335491 °	-121.335491 °
DWR ID	RD0524U01RM41.34				
Comment Code					
Inspector Comment					
09/13/2017: Pocket erosion above the protected levee toe. [2017 Site ID:RD0524U01RM41.34]

Front view of the erosion.

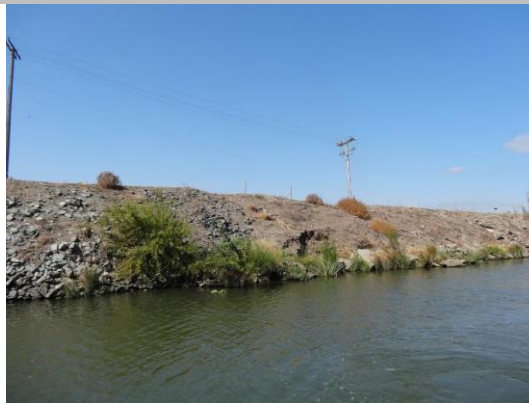
Photo 3 of 4 : SP_2018_RD0524_107_16_20180323_00035.jpg

Looking downstream of the erosion site.

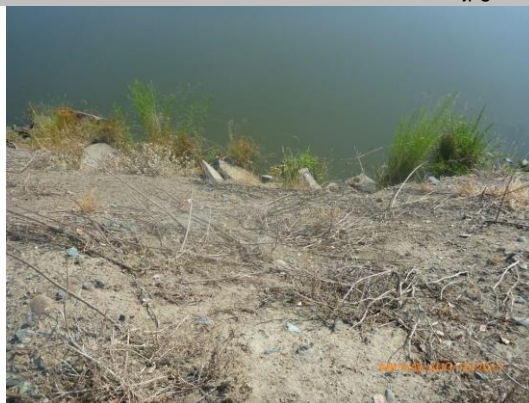
Photo 1 of 3 : LEVAL_SP_2018_541_4079.jpg

LM Start	0.70	Rating **	A/W	Issue No.	153
LM End	0.70	Issue Type +	Ma	Location *	
Category	Supplemental			GPS Latitude/Longitude	
				Start	End
Item	2017 Storm Damage			37.937500 °	37.937500 °
				-121.335500 °	-121.335500 °
DWR ID	DWR_RD0524_01_f_2017_153				
Comment Code					
Inspector Comment					
Levee Evaluation Comments					
Description:Slope protection repairs are needed along the waterside slope due to erosion and riprap displacement from high water. Based upon levee inspections, it was determined the waterside levee slope is eroding, deteriorating, and degrading. The eroded levee sections need to be restored back to design standards to prevent further deterioration and damage.					
Site ID No:541					
Site Designation:LMA-447					
Repair Type: Erosion					
Rating:Area of Concern					
Field Date:8/10/2017					
Notes:

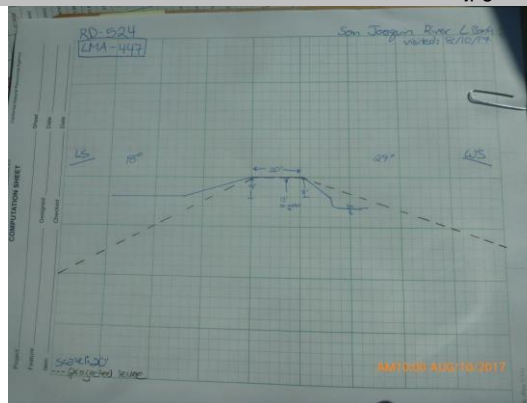
Photo 3 of 3 : LEVAL_SP_2018_541_4083.jpg

LM Start	0.70	Rating **	A/W	Issue No.	153 (cont)
LM End	0.70	Issue Type +	Ma	Location *	
Category	Supplemental			GPS Latitude/Longitude	
				Start	End
Item	2017 Storm Damage			37.937500 °	37.937500 °
				-121.335500 °	-121.335500 °
DWR ID	DWR_RD0524_01_f_2017_153				
Comment Code					
Inspector Comment					
Levee Evaluation Comments					
Description:Slope protection repairs are needed along the waterside slope due to erosion and riprap displacement from high water. Based upon levee inspections, it was determined the waterside levee slope is eroding, deteriorating, and degrading. The eroded levee sections need to be restored back to design standards to prevent further deterioration and damage.					
Site ID No:541					
Site Designation:LMA-447					
Repair Type: Erosion					
Rating:Area of Concern					
Field Date:8/10/2017					
Notes:

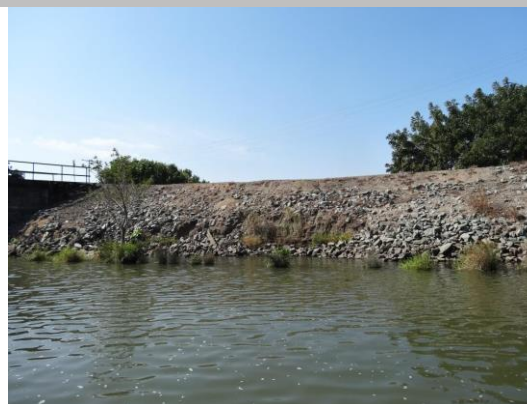
Photo 1 of 3 : SP_2018_RD0524_107_17_20180323_00037.jpg

LM Start	0.71	Rating **	M	Issue No.	17
LM End	0.73	Issue Type +	Ma	Location *	WS
Category	Supplemental			GPS Latitude/Longitude	
				Start	End
Item	DWR Erosion Survey			37.937222 °	37.937222 °
				-121.335277 °	-121.335277 °
DWR ID	RD0524U01RM41.36				
Comment Code					
Inspector Comment					
09/13/2017: No significant change observed.					
07/25/2016: No significant change observed.					
06/24/2015: The erosion site is immediately downstream of the RR bridge. [2017 Site ID:RD0524U01RM41.36]

Front view of the erosion.

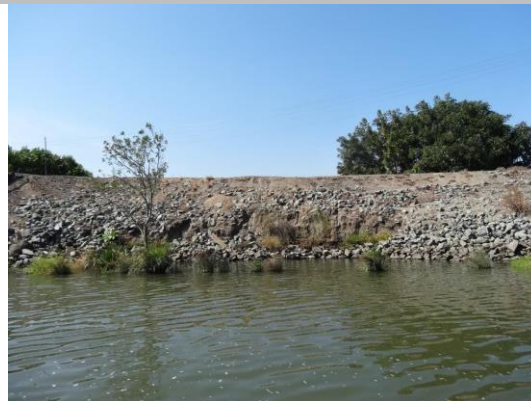
Photo 2 of 3 : SP_2018_RD0524_107_17_20180323_00038.jpg

LM Start	0.71	Rating **	M	Issue No.	17 (cont)	
LM End	0.73	Issue Type +	Ma	Location *	WS	
Category	Supplemental			GPS Latitude/Longitude		
				Start		End
Item	DWR Erosion Survey			37.937222 °		37.937222 °
				-121.335277 °		-121.335277 °
DWR ID	RD0524U01RM41.36					
Comment Code						
Inspector Comment						
09/13/2017: No significant change observed.						
07/25/2016: No significant change observed.						
06/24/2015: The erosion site is immediately downstream of the RR bridge. [2017 Site ID:RD0524U01RM41.36]

Close view of the erosion.

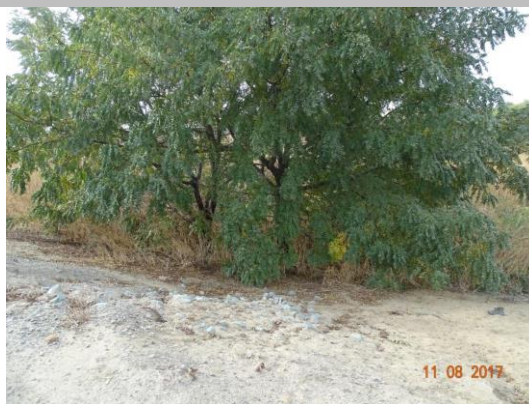
Photo 1 of 2 : SP_2018_RD0524_107_156_20180323_00219.jpg

LM Start	0.72	Rating **	M	Issue No.	156
LM End	0.72	Issue Type +	Ma	Location *	LS
Category	Earthen Levee			GPS Latitude/Longitude	
				Start	End
Item	Trim / Thin Trees			37.937258 °	37.937258 °
				-121.335373 °	-121.335373 °
DWR ID	DWR_RD0524_01_s_2017_156				
Comment Code					
T1 : Trim trees to at least five feet above ground level.					
Inspector Comment					
Dense vegetation on landside slope.

Looking southwest at the landside slope.

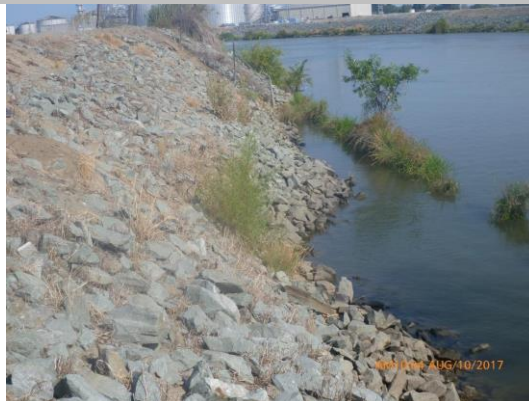
Photo 1 of 3 : LEVAL_SP_2018_540_4087.jpg

LM Start	0.72	Rating **	A/W	Issue No.	154
LM End	0.73	Issue Type +	Ma	Location *	
Category	Supplemental			GPS Latitude/Longitude	
				Start	End
Item	2017 Storm Damage			37.937200 °	37.937100 °
				-121.335300 °	-121.335300 °
DWR ID	DWR_RD0524_01_f_2017_154				
Comment Code					
Inspector Comment					
Levee Evaluation Comments					
Description:Slope protection repairs are needed along the waterside slope due to erosion and riprap displacement from high water. Based upon levee inspections, it was determined the waterside levee slope is eroding, deteriorating, and degrading. The eroded levee sections need to be restored back to design standards to prevent further deterioration and damage.					
Site ID No:540					
Site Designation:LMA-446					
Repair Type: Erosion					
Rating:Area of Concern					
Field Date:8/10/2017					
Notes:

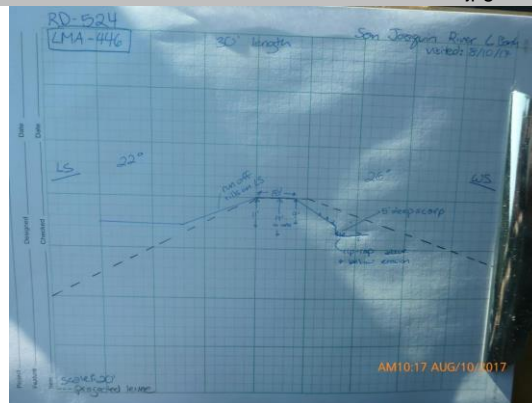
Photo 3 of 3 : LEVAL_SP_2018_540_4089.jpg

LM Start	0.72	Rating **	A/W	Issue No.	154 (cont)	
LM End	0.73	Issue Type +	Ma	Location *		
Category	Supplemental			GPS Latitude/Longitude		
				Start	End	
Item	2017 Storm Damage			37.937200 °	37.937100 °	
				-121.335300 °	-121.335300 °	
DWR ID	DWR_RD0524_01_f_2017_154					
Comment Code						
Inspector Comment						
Levee Evaluation Comments						
Description:Slope protection repairs are needed along the waterside slope due to erosion and riprap displacement from high water. Based upon levee inspections, it was determined the waterside levee slope is eroding, deteriorating, and degrading. The eroded levee sections need to be restored back to design standards to prevent further deterioration and damage.						
Site ID No:540						
Site Designation:LMA-446						
Repair Type: Erosion						
Rating:Area of Concern						
Field Date:8/10/2017						
Notes:

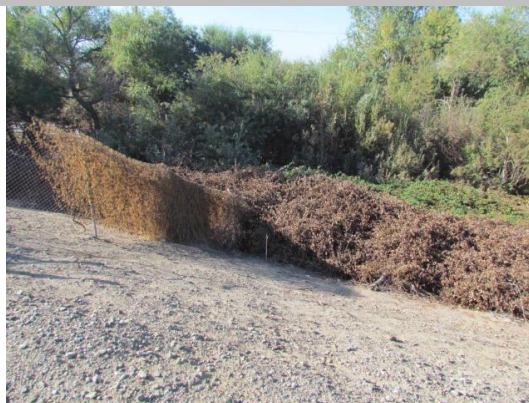
Photo 2 of 3 : SP_2018_RD0524_107_262_20180323_00365.jpg

LM Start	0.75	Rating **	U	Issue No.	262
LM End	0.78	Issue Type +	Ma	Location *	LS
Category	Earthen Levee			GPS Latitude/Longitude	
				Start	End
Item	Vegetation			37.936813 °	37.936539 °
				-121.335019 °	-121.334863 °
DWR ID	DWR_RD0524_01_s_2012_262				
Comment Code					
V2 : Remove the wild growth other than native grasses from the levee slopes.					
Inspector Comment					
Dense vegetation at landside toe along fence line.

Looking west at dense vegetation at landward slope and toe fall 2015.

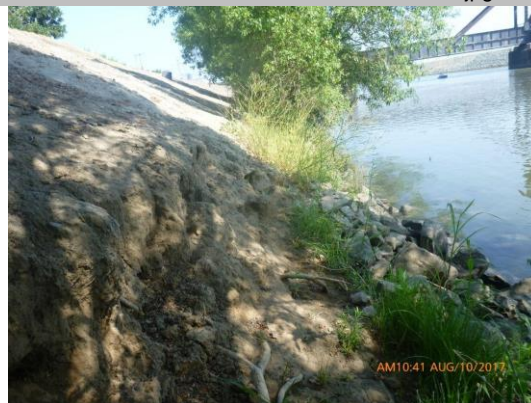
Photo 3 of 3 : LEVAL_SP_2018_538_4099.jpg

LM Start	0.79	Rating **	M	Issue No.	155 (cont)	
LM End	0.80	Issue Type +	Ma	Location *		
Category	Supplemental			GPS Latitude/Longitude		
				Start	End	
Item	2017 Storm Damage			37.936300 °	37.936200 °	
				-121.334700 °	-121.334600 °	
DWR ID	DWR_RD0524_01_f_2017_155					
Comment Code						
Inspector Comment						
Levee Evaluation Comments						
Description:Slope protection repairs are needed along the waterside slope due to erosion and riprap displacement from high water. Based upon levee inspections, it was determined the waterside levee slope is eroding, deteriorating, and degrading. The eroded levee sections need to be restored back to design standards to prevent further deterioration and damage.						
Site ID No:538						
Site Designation:LMA-444						
Repair Type: Erosion						
Rating:Area of Concern						
Field Date:8/10/2017						
Notes:

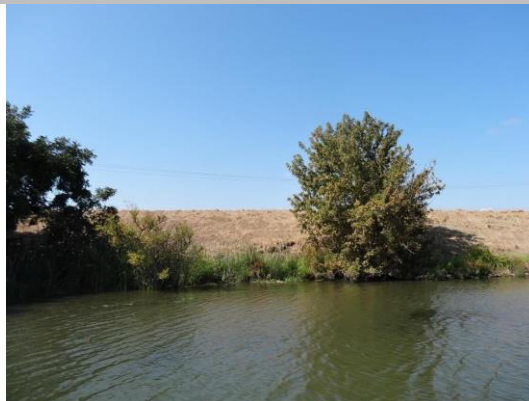
Photo 2 of 2 : SP_2018_RD0524_107_22_20180323_00053.jpg

LM Start	0.83	Rating **	U	Issue No.	22 (cont)
LM End	0.84	Issue Type +	Ma	Location *	WS
Category	Supplemental			GPS Latitude/Longitude	
				Start	End
Item	DWR Erosion Survey			37.935930 °	37.935930 °
				-121.334133 °	-121.334133 °
DWR ID	RD0524U01RM41.44				
Comment Code					
Inspector Comment					
09/13/2017: No significant change observed.					
07/25/2016: No significant change observed.					
06/24/2015: No significant change observed.					
06/19/2014: No significant change observed.					
08/13/2013: Site was discovered during boat survey. The dense vegetation blocks a clear view of the erosion. Size of erosion site was very roughly estimated. [2017 Site ID:RD0524U01RM41.44]

Close view of the erosion site.

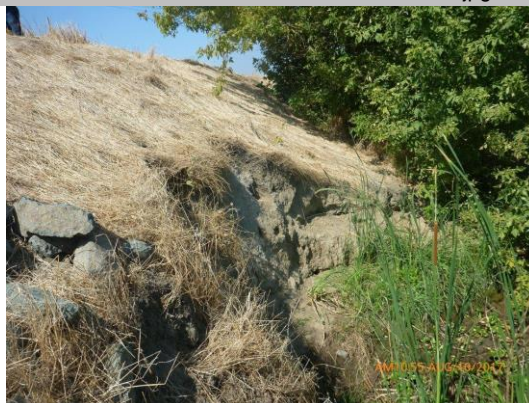
Photo 1 of 3 : LEVAL_SP_2018_537_4102.jpg

LM Start	0.90	Rating **	A/W	Issue No.	193
LM End	0.91	Issue Type +	Ma	Location *	
Category	Supplemental			GPS Latitude/Longitude	
				Start	End
Item	2017 Storm Damage			37.935400 °	37.935300 °
				-121.333300 °	-121.333200 °
DWR ID	DWR_RD0524_01_f_2017_193				
Comment Code					
Inspector Comment					
Levee Evaluation Comments					
Description:Slope protection repairs are needed along the waterside slope due to erosion and riprap displacement from high water. Based upon levee inspections, it was determined the waterside levee slope is eroding, deteriorating, and degrading. The eroded levee sections need to be restored back to design standards to prevent further deterioration and damage.					
Site ID No:537					
Site Designation:LMA-443					
Repair Type: Erosion					
Rating:Serious					
Field Date:8/10/2017					
Notes:

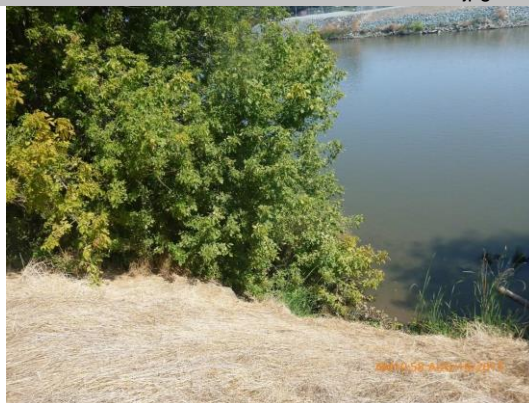
Photo 3 of 3 : LEVAL_SP_2018_537_4104.jpg

LM Start	0.90	Rating **	A/W	Issue No.	193 (cont)
LM End	0.91	Issue Type +	Ma	Location *	
Category	Supplemental			GPS Latitude/Longitude	
				Start	End
Item	2017 Storm Damage			37.935400 °	37.935300 °
				-121.333300 °	-121.333200 °
DWR ID	DWR_RD0524_01_f_2017_193				
Comment Code					
Inspector Comment					
Levee Evaluation Comments					
Description:Slope protection repairs are needed along the waterside slope due to erosion and riprap displacement from high water. Based upon levee inspections, it was determined the waterside levee slope is eroding, deteriorating, and degrading. The eroded levee sections need to be restored back to design standards to prevent further deterioration and damage.					
Site ID No:537					
Site Designation:LMA-443					
Repair Type: Erosion					
Rating:Serious					
Field Date:8/10/2017					
Notes:

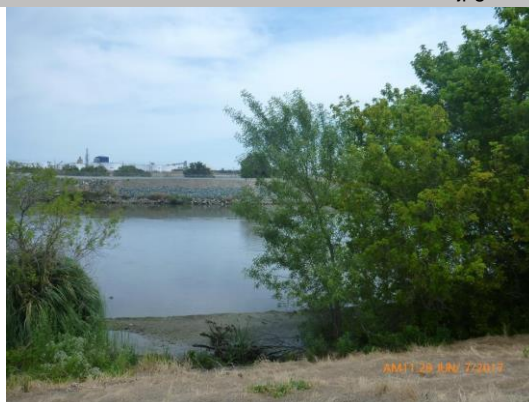
Photo 1 of 3 : LEVAL_SP_2018_87_1285.jpg

LM Start	0.91	Rating **	A/W	Issue No.	187
LM End		Issue Type +	Ma	Location *	
Category	Supplemental			GPS Latitude/Longitude	
				Start	End
Item	2017 Storm Damage			37.935580 °	°
				-121.333200 °	°
DWR ID	DWR_RD0524_01_f_2017_187				
Comment Code					
Inspector Comment					
Levee Evaluation Comments					
Description:					
Site ID No:87					
Site Designation:DWR_RD0524_01_s_2012_99					
Repair Type: Erosion					
Rating:Area of Concern					
Field Date:6/7/2017					
Notes: no observable defects to levee, vegetation blocks ws toe

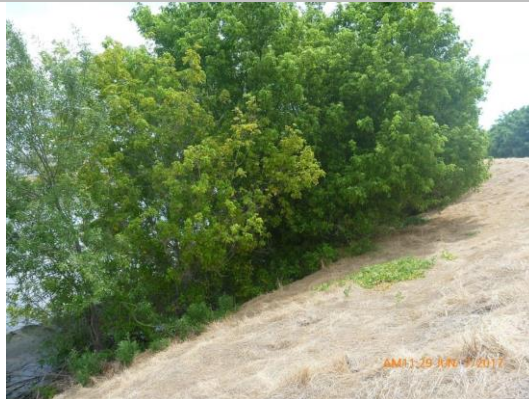
Photo 2 of 3 : LEVAL_SP_2018_87_1286.jpg

Notes: no observable defects to levee, vegetation blocks ws toe

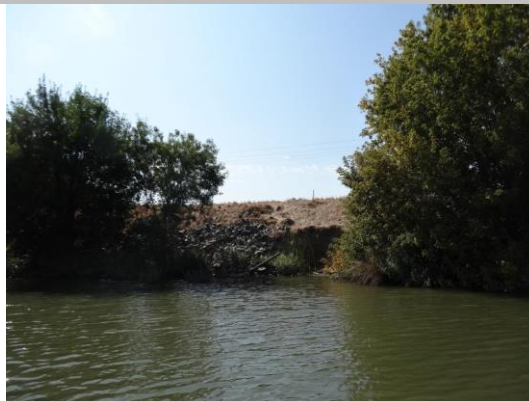
Photo 1 of 3 : SP_2018_RD0524_107_29_20180323_00062.jpg

LM Start	0.91	Rating **	U	Issue No.	29
LM End	0.91	Issue Type +	Ma	Location *	WS
Category	Supplemental			GPS Latitude/Longitude	
				Start	End
Item	DWR Erosion Survey			37.935576 °	37.935576 °
				-121.333202 °	-121.333202 °
DWR ID	RD0524U01RM41.5				
Comment Code					
Inspector Comment					
09/13/2017: No significant change observed.					
07/25/2016: No significant change observed.					
06/24/2015: No significant change observed.					
06/19/2014: No significant change observed.					
08/13/2013: No significant change at this site.					
08/07/2012: The site has been visited by boat survey. No significant change observed					
08/23/2011: The erosion site is immediately downstream of the riprap protection. [2017 Site ID:RD0524U01RM41.5]

Front view of the erosion. Note the riprap protection near the site.

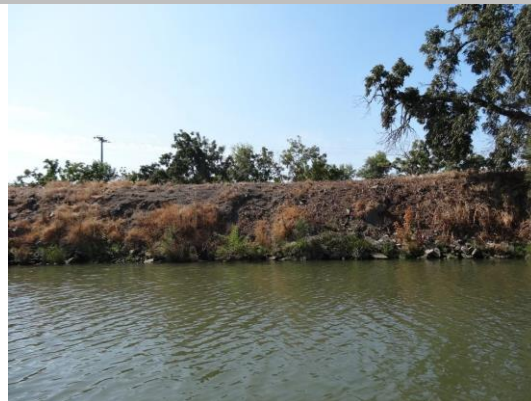
Photo 3 of 4 : SP_2018_RD0524_107_30_20180323_00067.jpg

LM Start	1.00	Rating **	U	Issue No.	30 (cont)
LM End	1.00	Issue Type +	Ma	Location *	WS
Category	Supplemental			GPS Latitude/Longitude	
				Start	End
Item	DWR Erosion Survey			37.935410 °	37.935410 °
				-121.331560 °	-121.331560 °
DWR ID	RD0524U01RM41.58				
Comment Code					
Inspector Comment					
09/13/2017: No significant change observed.					
07/25/2016: No significant change observed.					
06/24/2015: No significant change observed.					
06/19/2014: No significant change observed.					
08/13/2013: No significant change at this site.					
08/07/2012: The erosion was discovered during the boat survey. [2017					
Site ID:RD0524U01RM41.58]

Front view of the erosion.

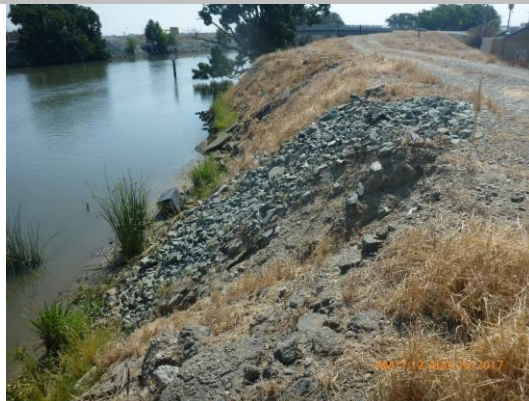
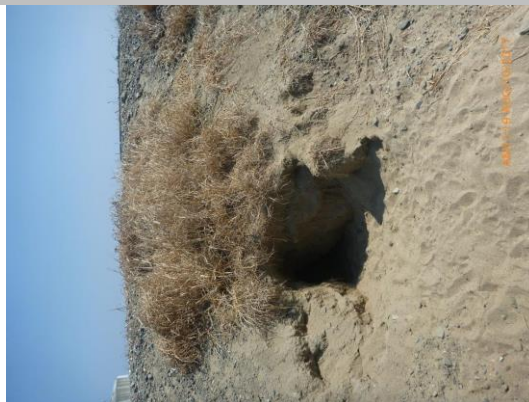
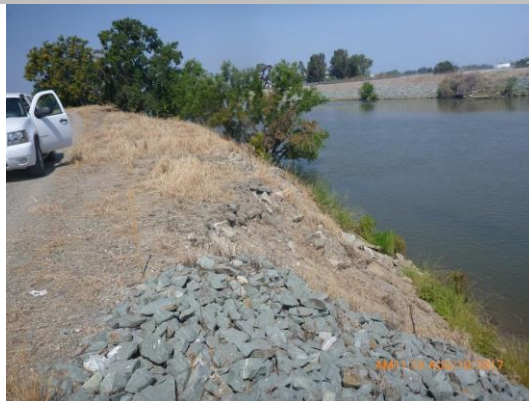
Comment Code					
Inspector Comment					
Levee Evaluation Comments					
Description:Slope protection repairs are needed along the waterside slope due to erosion and riprap displacement from high water. Based upon levee inspections, it was determined the waterside levee slope is eroding, deteriorating, and degrading. The eroded levee sections need to be restored back to design standards to prevent further deterioration and damage.					
Site ID No:536					
Site Designation:LMA-442					
Repair Type: Erosion					
Rating:Area of Concern					
Field Date:8/10/2017					
Notes: Appears to be previous repair site adjacent to LMA-442. Large fox den on land side

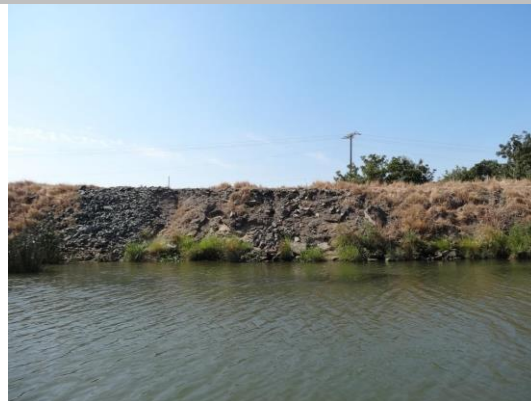
Photo 2 of 3 : SP_2018_RD0524_107_33_20180323_00076.jpg

Comment Code					
Inspector Comment					
09/13/2017: No significant change observed.					
07/25/2016: No significant change observed.					
06/24/2015: No significant change observed.					
06/19/2014: No significant change observed.					
08/13/2013: No significant change at this site.					
08/07/2012: The site has been visited by boat survey. Site has been repaired, but new erosion occurred at the levee slope and immediately upstream of the repaired site.					
08/23/2011: The site is about 500 ft downstream of bridge. The levee toe seems to be protected, but the protection is being washed away.					
[2017 Site ID:RD0524U01RM41.59]

Close view of the erosion.

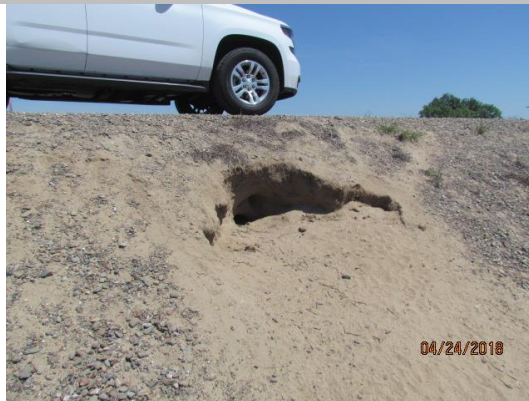
Photo 1 of 4 : SP_2018_RD0524_107_238_20180427_00490.jpg

Looking east at large rodent hole on landward slope. (Spring 2018)

LM Start	1.02	Rating **	U	Issue No.	238 (cont)	
LM End	1.02	Issue Type +	Ma	Location *	LS	
Category	Earthen Levee			GPS Latitude/Longitude		
				Start		End
Item	Animal Control			37.934991 °	37.934991 °	
				-121.331160 °	-121.331160 °	
DWR ID	DWR_RD0524_01_f_2017_238					
Comment Code						
A3 : No rodents visible, but rodent burrows visible; need to backfill and compact or grout burrows.						
Inspector Comment						
Two large rodent holes on landward slope and toe. Large erosion around holes.

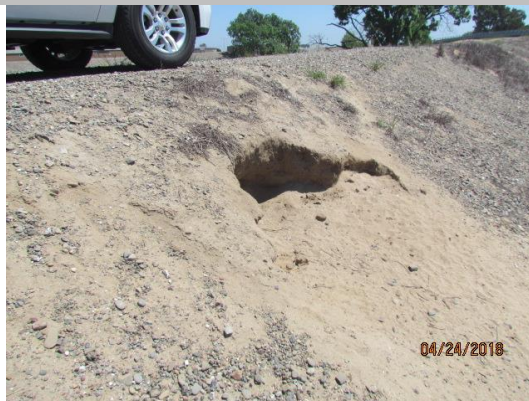
Photo 2 of 4 : SP_2018_RD0524_107_238_20180427_00492.jpg

Looking southeast at rodent hole on landward slope. (Spring 2018)

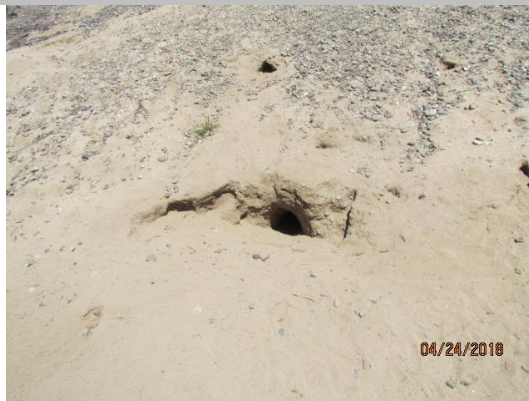
Photo 3 of 4 : SP_2018_RD0524_107_238_20180427_00491.jpg

Looking northeast at rodent hole on landward slope. (Spring 2018)

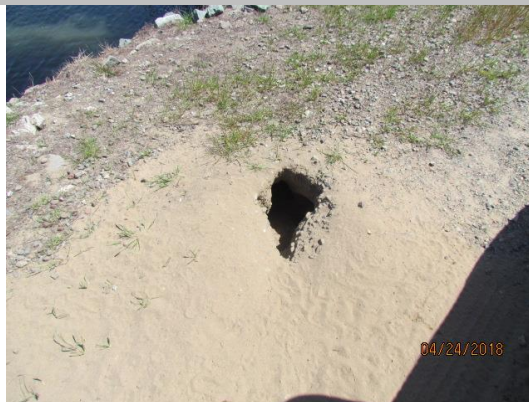
Photo 1 of 3 : SP_2018_RD0524_107_150_20180427_00493.jpg

LM Start	1.04	Rating **	U	Issue No.	150
LM End	1.04	Issue Type +	Ma	Location *	WS
Category	Earthen Levee			GPS Latitude/Longitude	
				Start	End
Item	Animal Control			37.934896 °	37.934896 °
				-121.330781 °	-121.330781 °
DWR ID	DWR_RD0524_01_s_2018_150				
Comment Code					
A3 : No rodents visible, but rodent burrows visible; need to backfill and compact or grout burrows.					
Inspector Comment					
Large rodent or beaver or nutria hole on waterward shoulder and crown of levee. Over 2 cubic feet of material was observed beside hole.

Looking at close-up view of rodent hole on waterward shoulder. (Spring 2018)

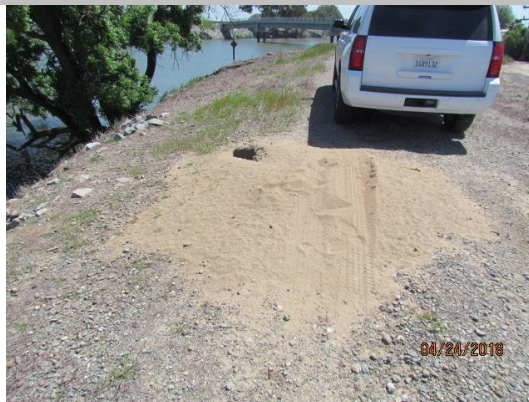
Photo 2 of 3 : SP_2018_RD0524_107_150_20180427_00494.jpg

Looking south at large rodent hole on waterward shoulder. (Spring 2018)

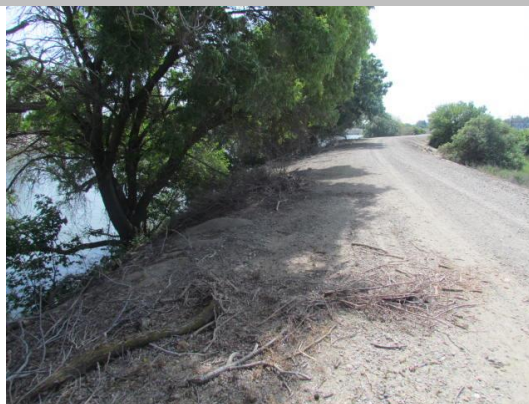
Photo 1 of 1 : SP_2018_RD0524_107_171_20180323_00235.jpg

LM Start	1.12	Rating **	M	Issue No.	171
LM End	1.16	Issue Type +	Ma	Location *	WS
Category	Earthen Levee			GPS Latitude/Longitude	
				Start	End
Item	Encroachments			37.934225 °	37.933815 °
				-121.329693 °	-121.329242 °
DWR ID	DWR_RD0524_01_s_2015_171				
Comment Code					
PR : Prunings					
Inspector Comment					
Prunings left on waterside shoulder and slope.

Looking south at prunings on waterward shoulders.

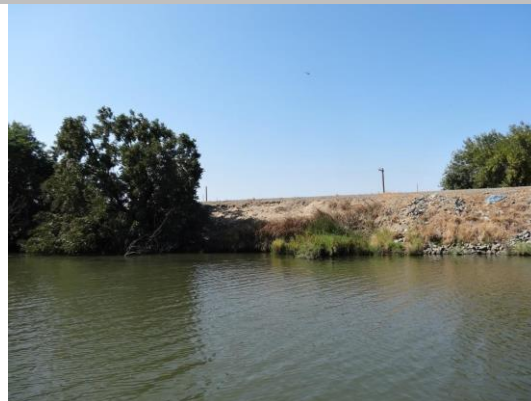
Photo 1 of 4 : SP_2018_RD0524_107_44_20180323_00094.jpg

Comment Code					
Inspector Comment					
09/13/2017: No significant change observed.					
07/25/2016: No significant change observed.					
06/24/2015: No significant change observed.					
06/19/2014: No significant change observed.					
08/13/2013: No significant change at this site.					
08/07/2012: The site has been visited by boat survey. No significant change observed					
08/23/2011: No significant change observed on site.					
09/07/2010: No significant change observed on site. Vegetation is visible at the water line. There is an exposed pipe discharge partially hanging at the mid-slope, possibly still used for discharging irrigation/runoff water. There is minimal rip rap protection along the bank, and what's left of it is no longer adequately protecting the bank.					
9/29/2009: Site consists of a 400-foot long eroding bank with minimal vegetation and protection; the existing rip rap has sloughed, rendering it useless; note that there is an exposed section of a pipe.

10/18/2006: There is extensive loss of rip rap on some sections; sewage disposal pond is on the landside of the levee; there is an exposed pipe outlet "hanging" from the upper slope. [2017 Site ID:RD0524U01RM41.79]

Direct view of the site.

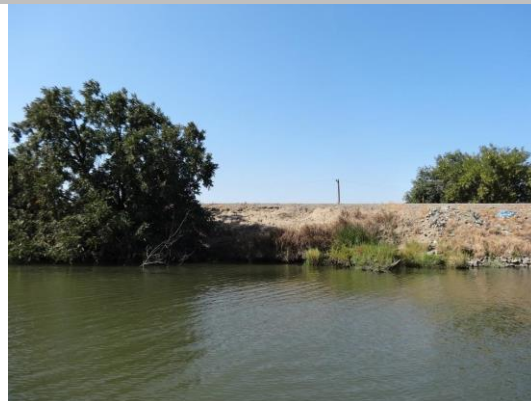
Photo 3 of 4 : SP_2018_RD0524_107_44_20180323_00096.jpg

Comment Code					
Inspector Comment					
09/13/2017: No significant change observed.					
07/25/2016: No significant change observed.					
06/24/2015: No significant change observed.					
06/19/2014: No significant change observed.					
08/13/2013: No significant change at this site.					
08/07/2012: The site has been visited by boat survey. No significant change observed					
08/23/2011: No significant change observed on site.					
09/07/2010: No significant change observed on site. Vegetation is visible at the water line. There is an exposed pipe discharge partially hanging at the mid-slope, possibly still used for discharging irrigation/runoff water. There is minimal rip rap protection along the bank, and what's left of it is no longer adequately protecting the bank.					
9/29/2009: Site consists of a 400-foot long eroding bank with minimal vegetation and protection; the existing rip rap has sloughed, rendering it useless; note that there is an exposed section of a pipe.

10/18/2006: There is extensive loss of rip rap on some sections; sewage disposal pond is on the landside of the levee; there is an exposed pipe outlet "hanging" from the upper slope. [2017 Site ID:RD0524U01RM41.79]

View of the erosion.

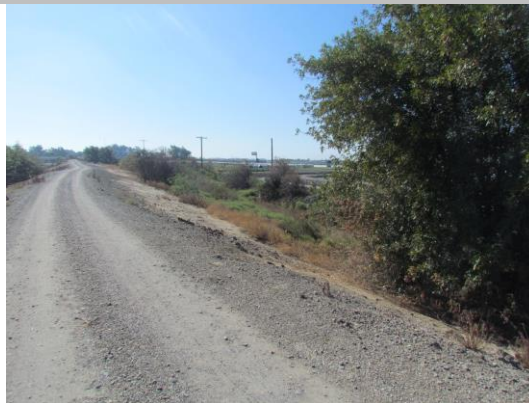
Photo 1 of 1 : SP_2018_RD0524_107_915_20180323_00376.jpg

LM Start	1.16	Rating **	U	Issue No.	915
LM End	1.23	Issue Type +	Ma	Location *	LS
Category	Earthen Levee			GPS Latitude/Longitude	
				Start	End
Item	Vegetation			37.933775 °	37.932784 °
				-121.329250 °	-121.328765 °
DWR ID	DWR_RD0524_01_s_2012_915				
Comment Code					
V2 : Remove the wild growth other than native grasses from the levee slopes.					
Inspector Comment					
Control veg at landside toe and berm.

Looking southwest at dense veg at landward toe and berm. (Fall 2016)

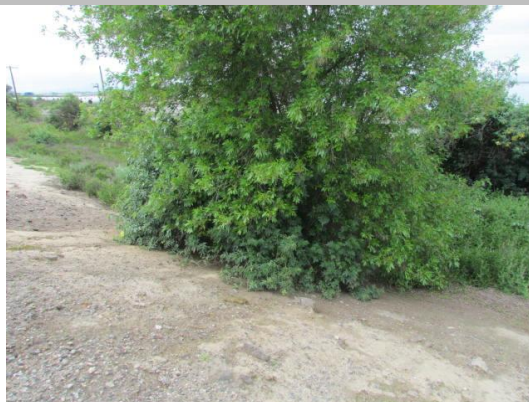
Photo 1 of 1 : SP_2018_RD0524_107_206_20180323_00287.jpg

Looking southwest a untrimmed tree at landward toe. (Spring 2016)

LM Start	1.17	Rating **	U	Issue No.	206
LM End	1.17	Issue Type +	Ma	Location *	LS
Category	Earthen Levee			GPS Latitude/Longitude	
				Start	End
Item	Trim / Thin Trees			37.933591 °	37.933591 °
				-121.329154 °	-121.329154 °
DWR ID	DWR_RD0524_01_s_2016_206				
Comment Code					
T1 : Trim trees to at least five feet above ground level.					
Inspector Comment

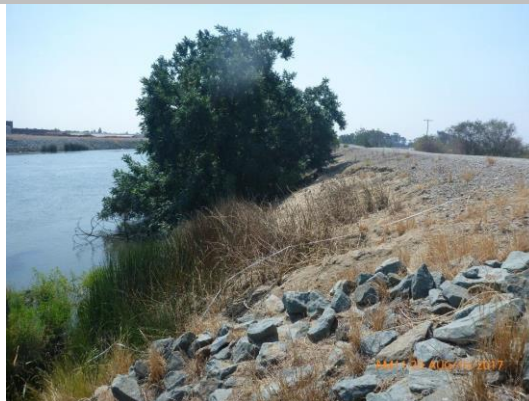
Photo 1 of 3 : LEVAL_SP_2018_535_4115.jpg

LM Start	1.18	Rating **	A/W	Issue No.	221
LM End	1.20	Issue Type +	Ma	Location *	
Category	Supplemental			GPS Latitude/Longitude	
				Start	End
Item	2017 Storm Damage			37.933500 °	37.933200 °
				-121.329100 °	-121.328900 °
DWR ID	DWR_RD0524_01_f_2017_221				
Comment Code					
Inspector Comment					
Levee Evaluation Comments					
Description:Slope protection repairs are needed along the waterside slope due to erosion and riprap displacement from high water. Based upon levee inspections, it was determined the waterside levee slope is eroding, deteriorating, and degrading. The eroded levee sections need to be restored back to design standards to prevent further deterioration and damage.					
Site ID No:535					
Site Designation:LMA-441					
Repair Type: Erosion					
Rating:Area of Concern					
Field Date:8/10/2017					
Notes:

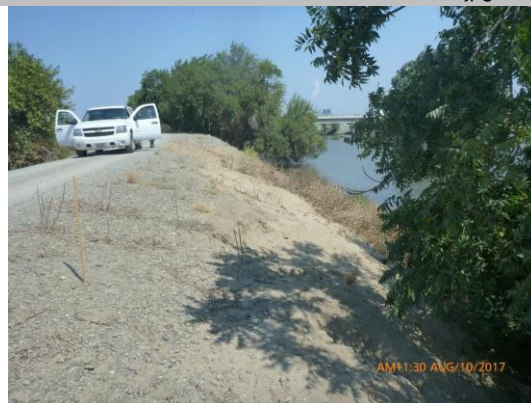
Photo 3 of 3 : LEVAL_SP_2018_535_4117.jpg

LM Start	1.18	Rating **	A/W	Issue No.	221 (cont)
LM End	1.20	Issue Type +	Ma	Location *	
Category	Supplemental			GPS Latitude/Longitude	
				Start	End
Item	2017 Storm Damage			37.933500 °	37.933200 °
				-121.329100 °	-121.328900 °
DWR ID	DWR_RD0524_01_f_2017_221				
Comment Code					
Inspector Comment					
Levee Evaluation Comments Description: Slope protection repairs are needed along the waterside slope due to erosion and riprap displacement from high water. Based upon levee inspections, it was determined the waterside levee slope is eroding, deteriorating, and degrading. The eroded levee sections need to be restored back to design standards to prevent further deterioration and damage. Site ID No: 535 Site Designation: LMA-441 Repair Type: Erosion Rating: Area of Concern Field Date: 8/10/2017 Notes:

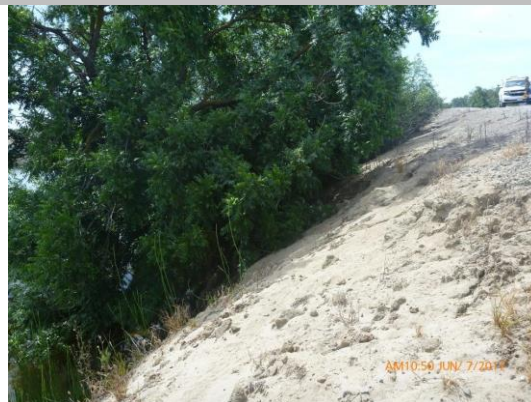
Photo 1 of 3 : LEVAL_SP_2018_84_1225.jpg

LM Start	1.19	Rating **	A/W	Issue No.	220
LM End		Issue Type +	Ma	Location *	
Category	Supplemental			GPS Latitude/Longitude	
				Start	End
Item	2017 Storm Damage			37.933347 °	°
				-121.329110 °	°
DWR ID	DWR_RD0524_01_f_2017_220				
Comment Code					
Inspector Comment					
Levee Evaluation Comments Description: Site ID No: 84 Site Designation: FSRP-13-42 Repair Type: Erosion Rating: Area of Concern Field Date: 6/7/2017 Notes:

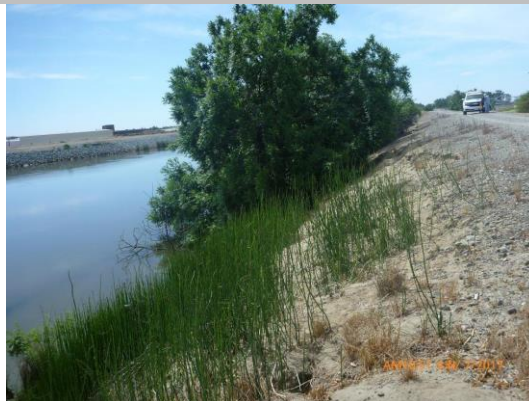
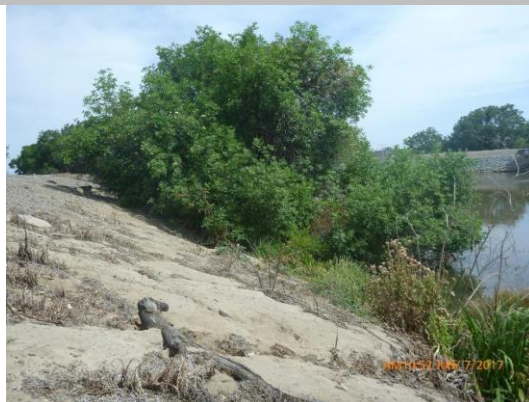
LM Start	1.19	Rating **	A/W	Issue No.	220 (cont)	
LM End		Issue Type +	Ma	Location *		
Category	Supplemental			GPS Latitude/Longitude		
				Start	End	
Item	2017 Storm Damage			37.933347 °		°
				-121.329110 °		°
DWR ID	DWR_RD0524_01_f_2017_220					
Comment Code						
Inspector Comment						
Levee Evaluation Comments						
Description:						
Site ID No:84						
Site Designation:FSRP-13-42						
Repair Type: Erosion						
Rating:Area of Concern						
Field Date:6/7/2017						
Notes:

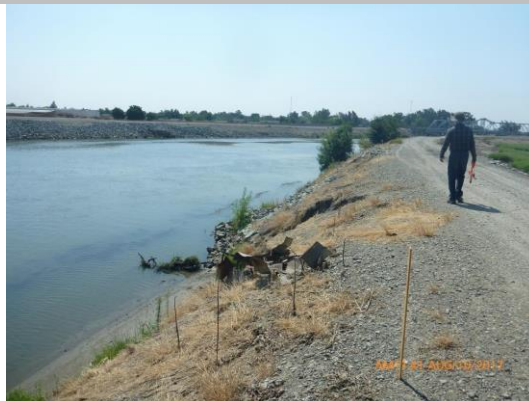
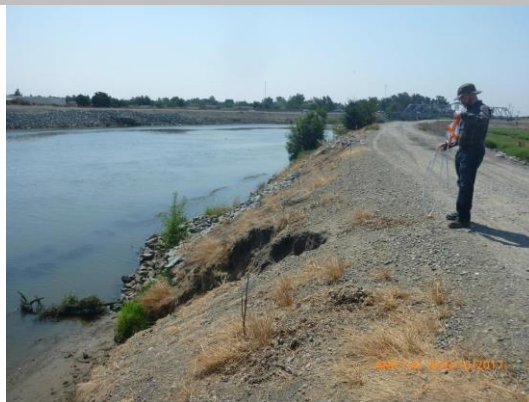
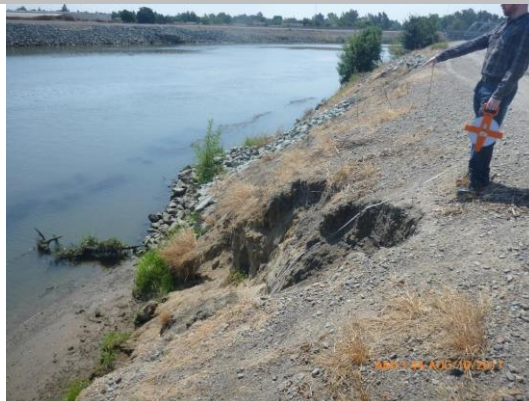
Description: Slope protection repairs are needed along the waterside slope due to erosion and riprap displacement from high water. Based upon levee inspections, it was determined the waterside levee slope is eroding, deteriorating, and degrading. The eroded levee sections need to be restored back to design standards to prevent further deterioration and damage.

Item	2017 Storm Damage			37.932600 °	37.931900 °	
				-121.328700 °	-121.328400 °	
DWR ID	DWR_RD0524_01_f_2017_222					
Comment Code						
Inspector Comment						
Levee Evaluation Comments						
Description:Slope protection repairs are needed along the waterside slope due to erosion and riprap displacement from high water. Based upon levee inspections, it was determined the waterside levee slope is eroding, deteriorating, and degrading. The eroded levee sections need to be restored back to design standards to prevent further deterioration and damage.						
Site ID No:534						
Site Designation:LMA-440						
Repair Type: Erosion						
Rating:Serious						
Field Date:8/10/2017						
Notes: site is related to, but not combined with, LMA-439 a portion of this site has been repaired.
